ORNL-5039
UC-41-Health and Safety

EXPEDIENT SHELTER CONSTRUCTION AND
OCCUPANCY EXPERIMENTS

Cresson H. Kearny

MARCH 1976

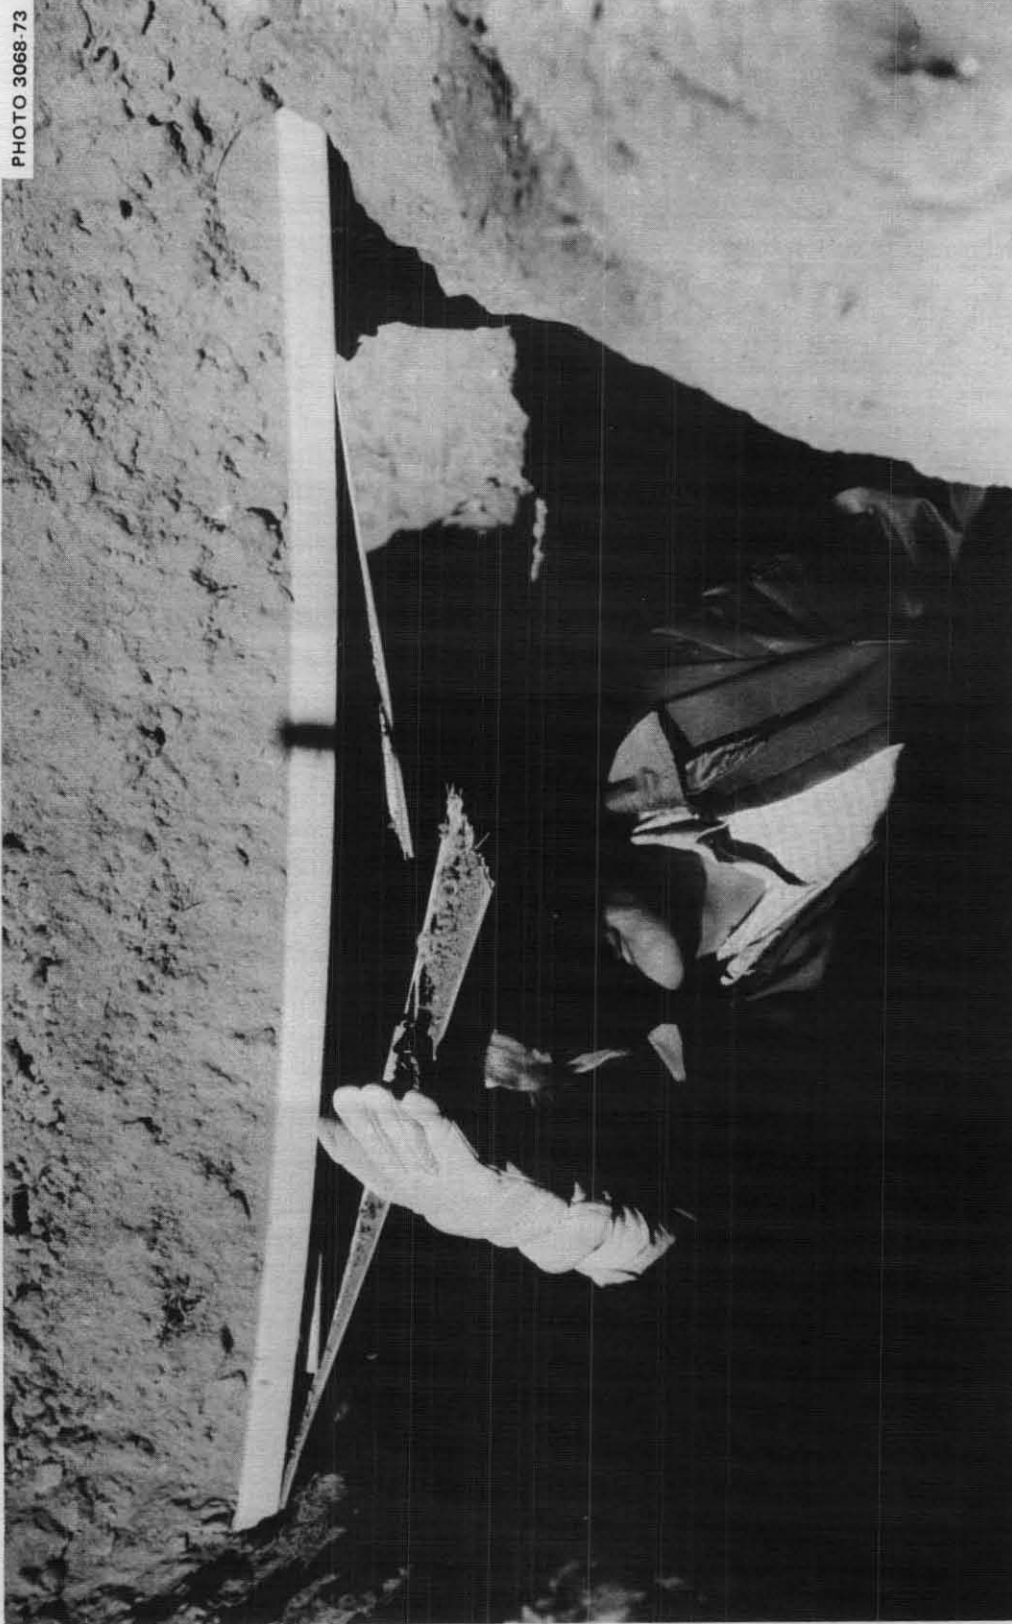
PHOTO 3068-73

Fig. 3.9. View of the most damaged door after the removal of the adjacent door. Removal of some of the weight on the $1\frac{1}{2} \times 1\frac{1}{2}$ -in. pine board that formed the unbroken frame of this door resulted in its becoming less bowed. The dry-earth bank pictured above this door appears to be vertical but actually was not. Kearny concluded that all that is needed to build a blast shelter in areas with stable and adequately deep earth is: (1) a deformable membrane (such as a tarp or rug) strong enough to support the weight of earth between it and the bottom of the earth arch formed by downward stresses and strains in the earth above the membrane; (2) the earth itself plus some practical although uncommon knowledge of how to use merely such a deformable membrane and earth to build a blast-protective roof over a trench.

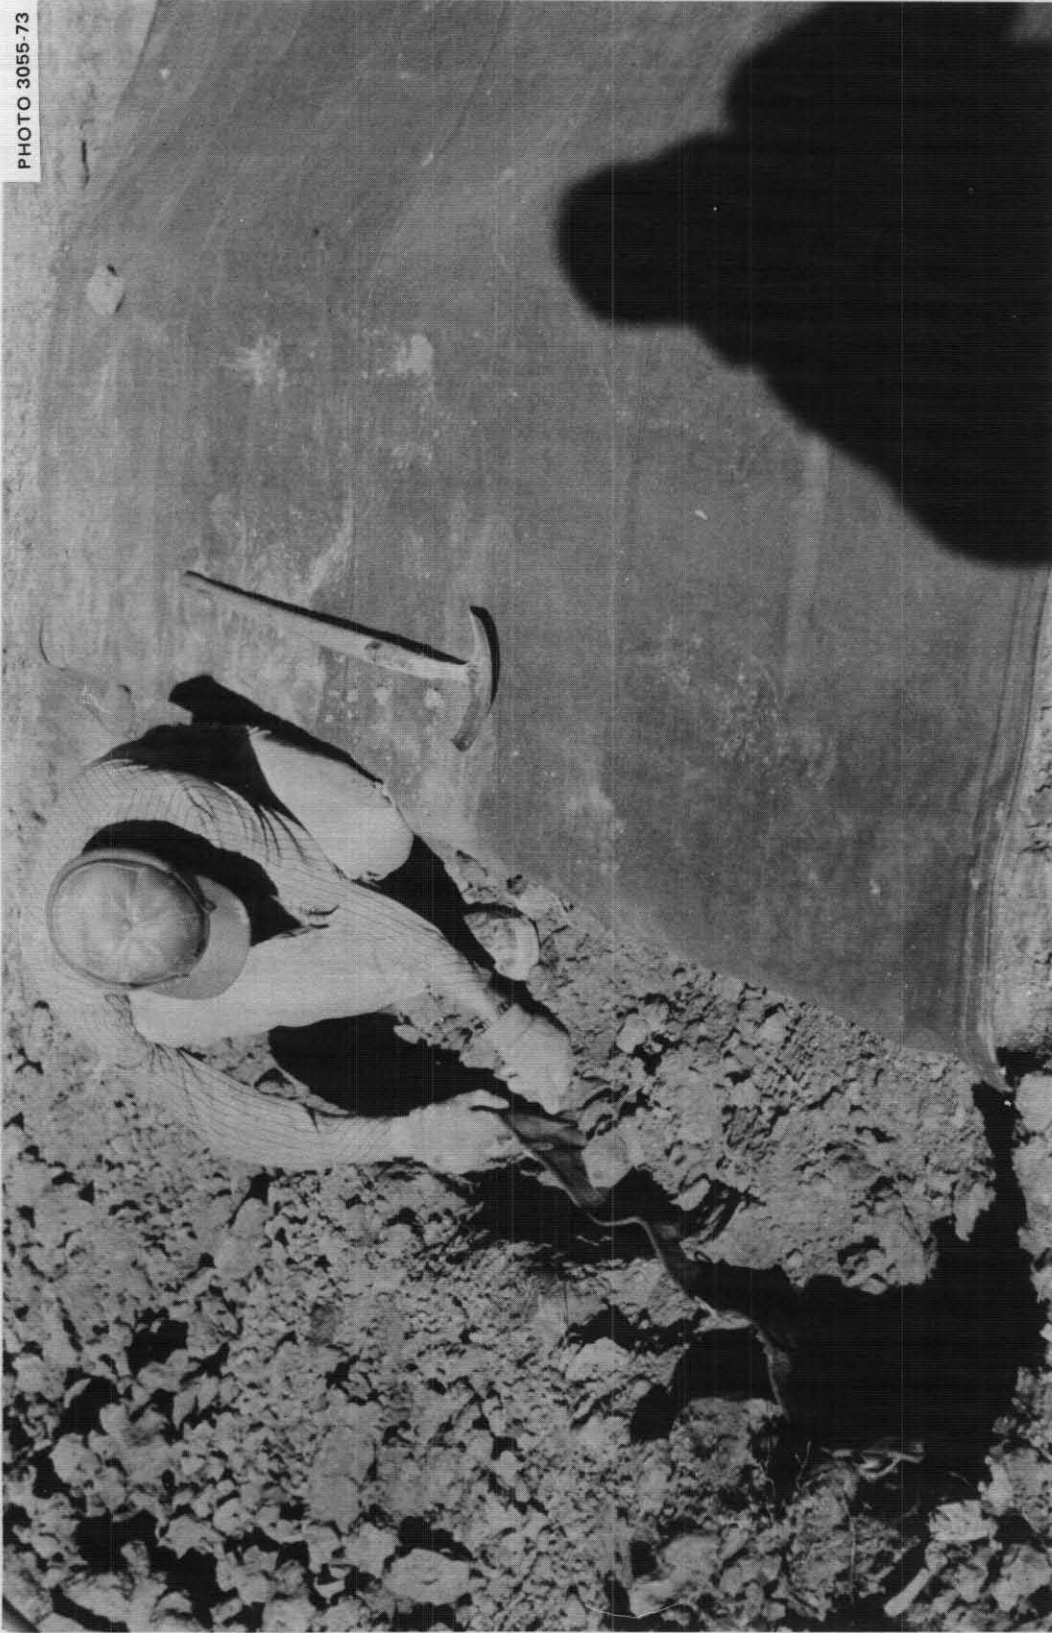
Fig. 3.11. Building the best of two successful Tarp-Roofed Trench Shelters constructed on Dec. 1, 1973, on the Kearny farm near Montrose, Colorado. C. H. Kearny designed this shelter after the November tests of the Door-Covered Trench Shelter had convinced him that, if the principles of earth arching and friction are used properly, then blast shelters can be built in many areas by roofing a trench with only a tarp or a strong rug, and then intelligently covering the tarp or rug with earth.

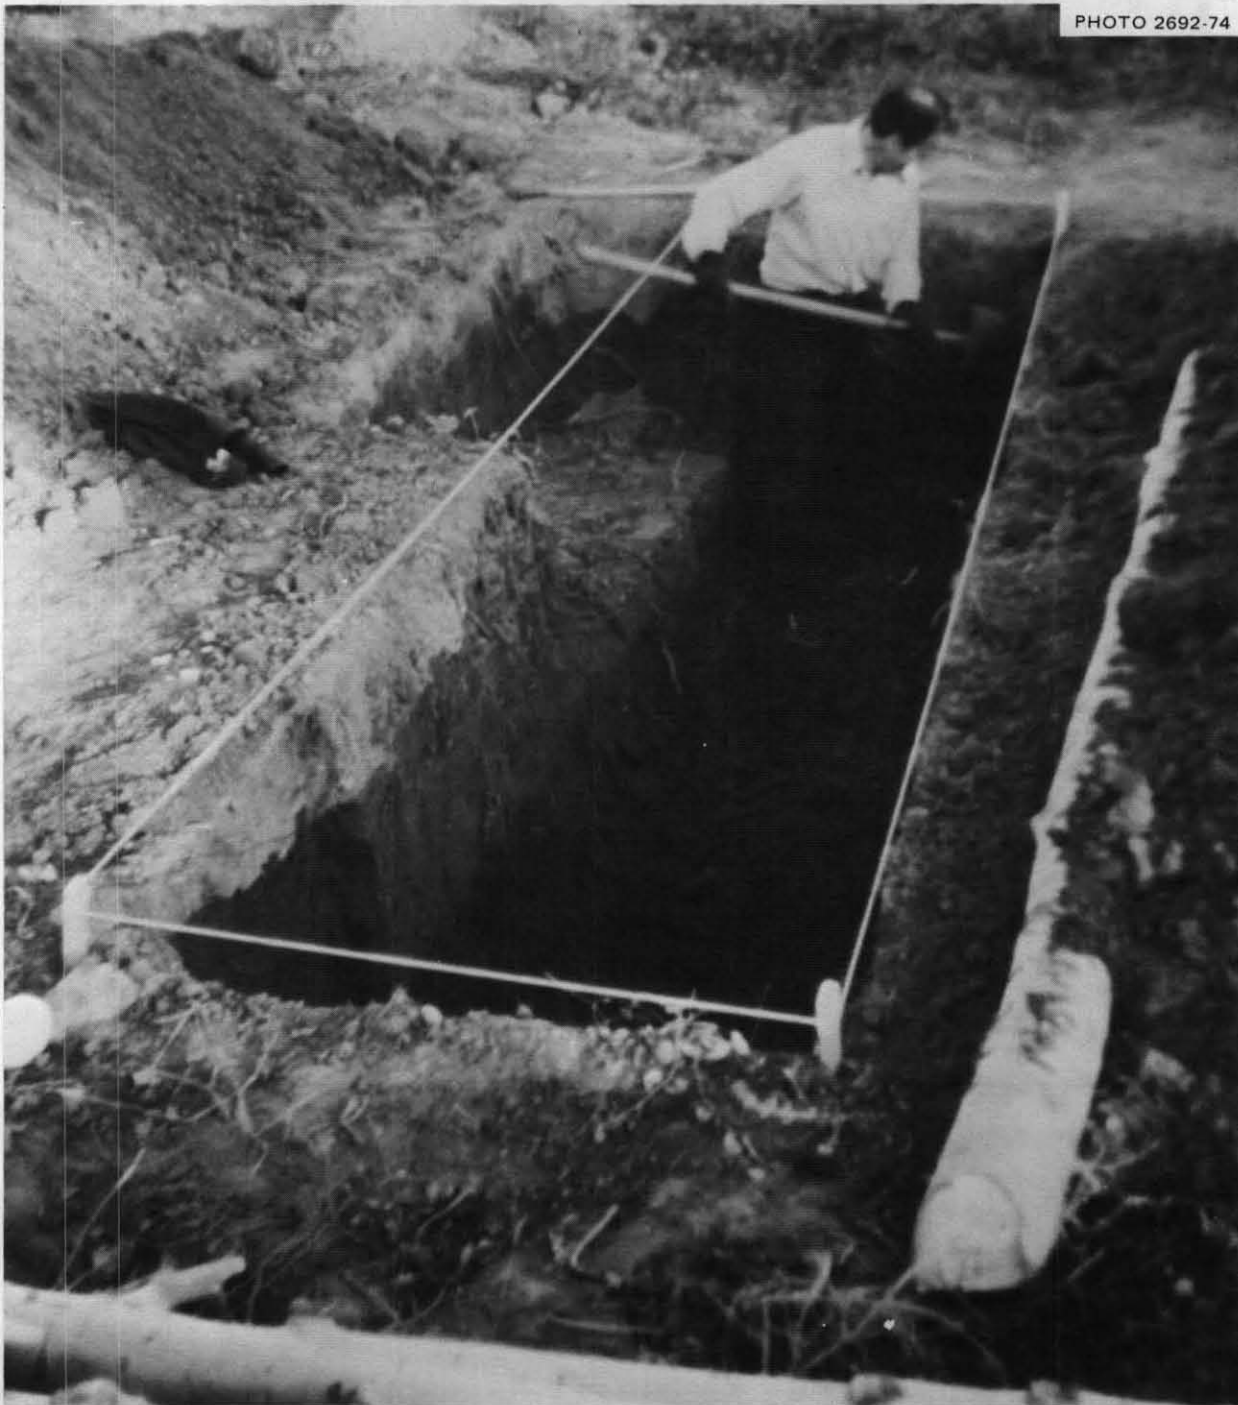
Fig. 4.4. Expanding the shelter room to its full specified width of $3\frac{1}{2}$ feet, and to its $4\frac{1}{2}$ -ft depth. This intelligent man made unnecessary work for himself by not following the instructions to cut a $3\frac{1}{2}$ -ft stick, and then use it repeatedly to be sure the trench was being dug full width.

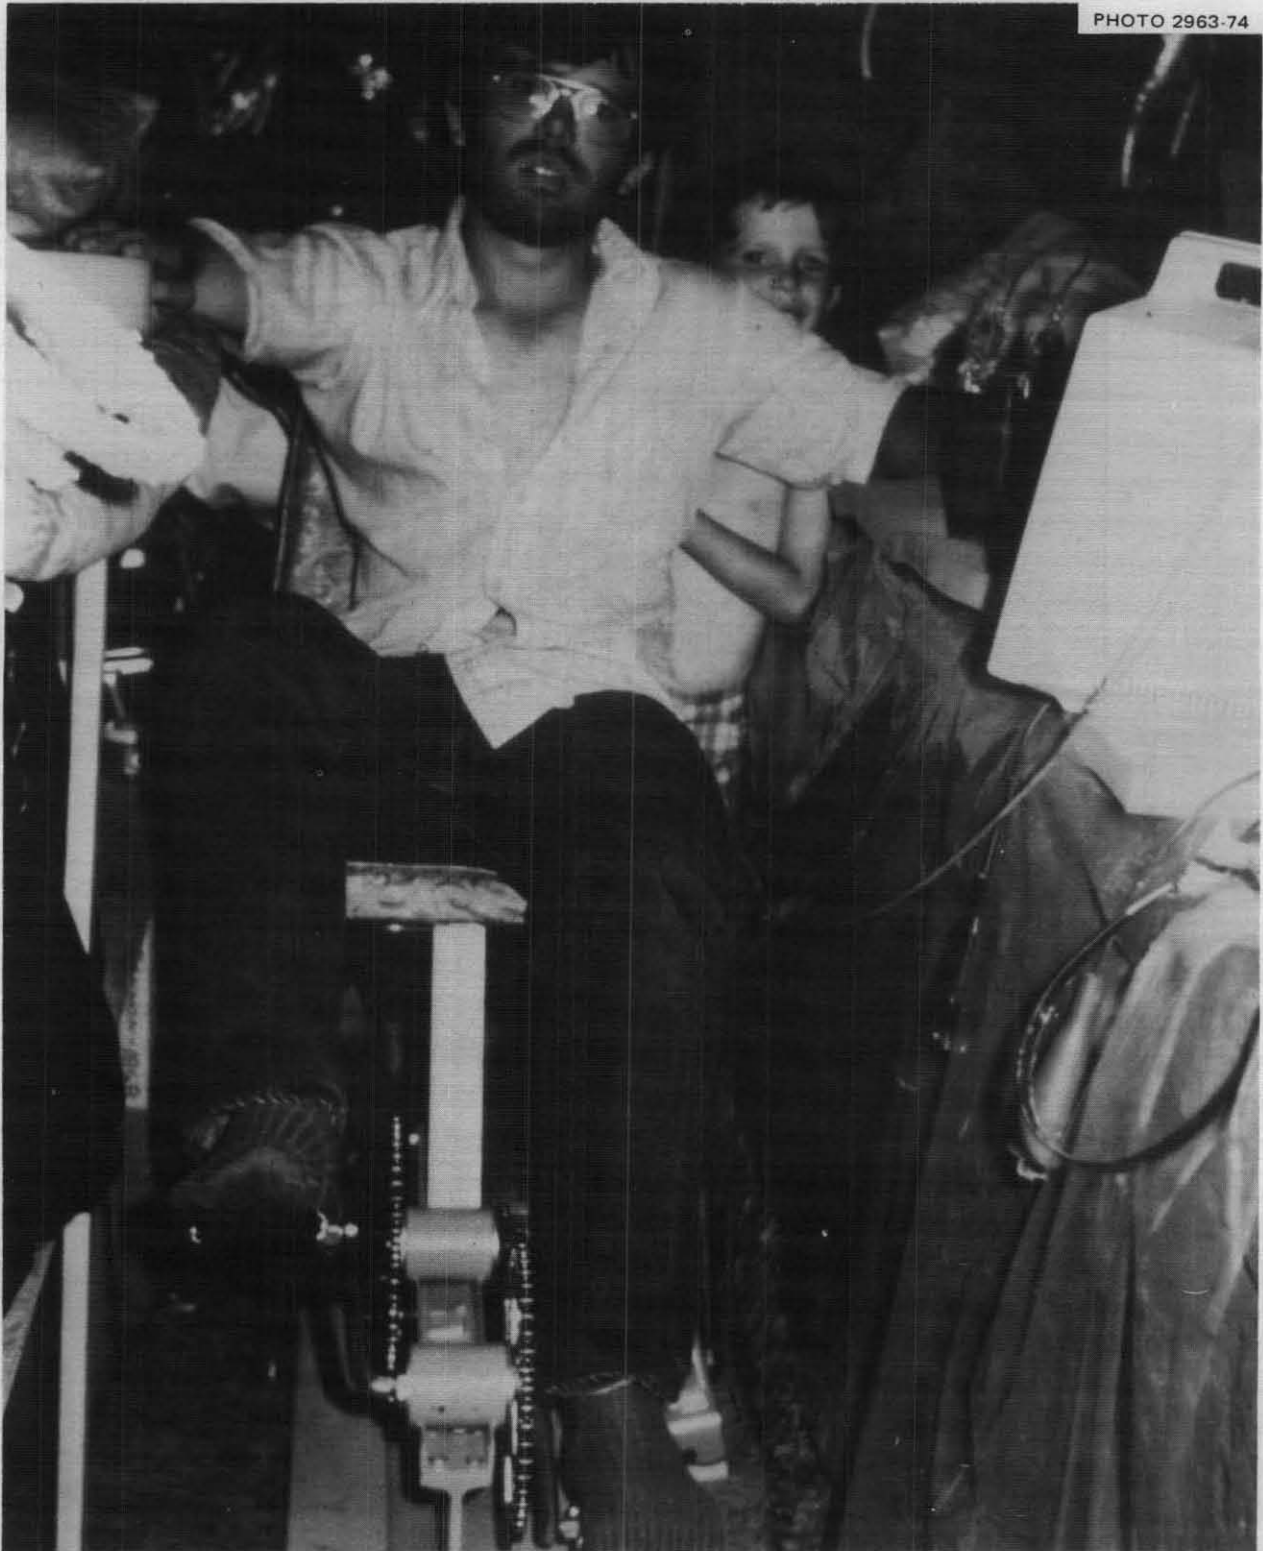
Fig. 4.20. The 18-year-old son getting good exercise by peddling his father's homemade generator to operate their portable TV set. Several years ago the father made this manually powered generator, which uses the sprockets and chains of two bicycles, mounted on a steel frame, to rotate the alternator from a car. The alternator is mounted on a bracket. Only a few minutes were required to remove the alternator and attach it securely to the bracket.

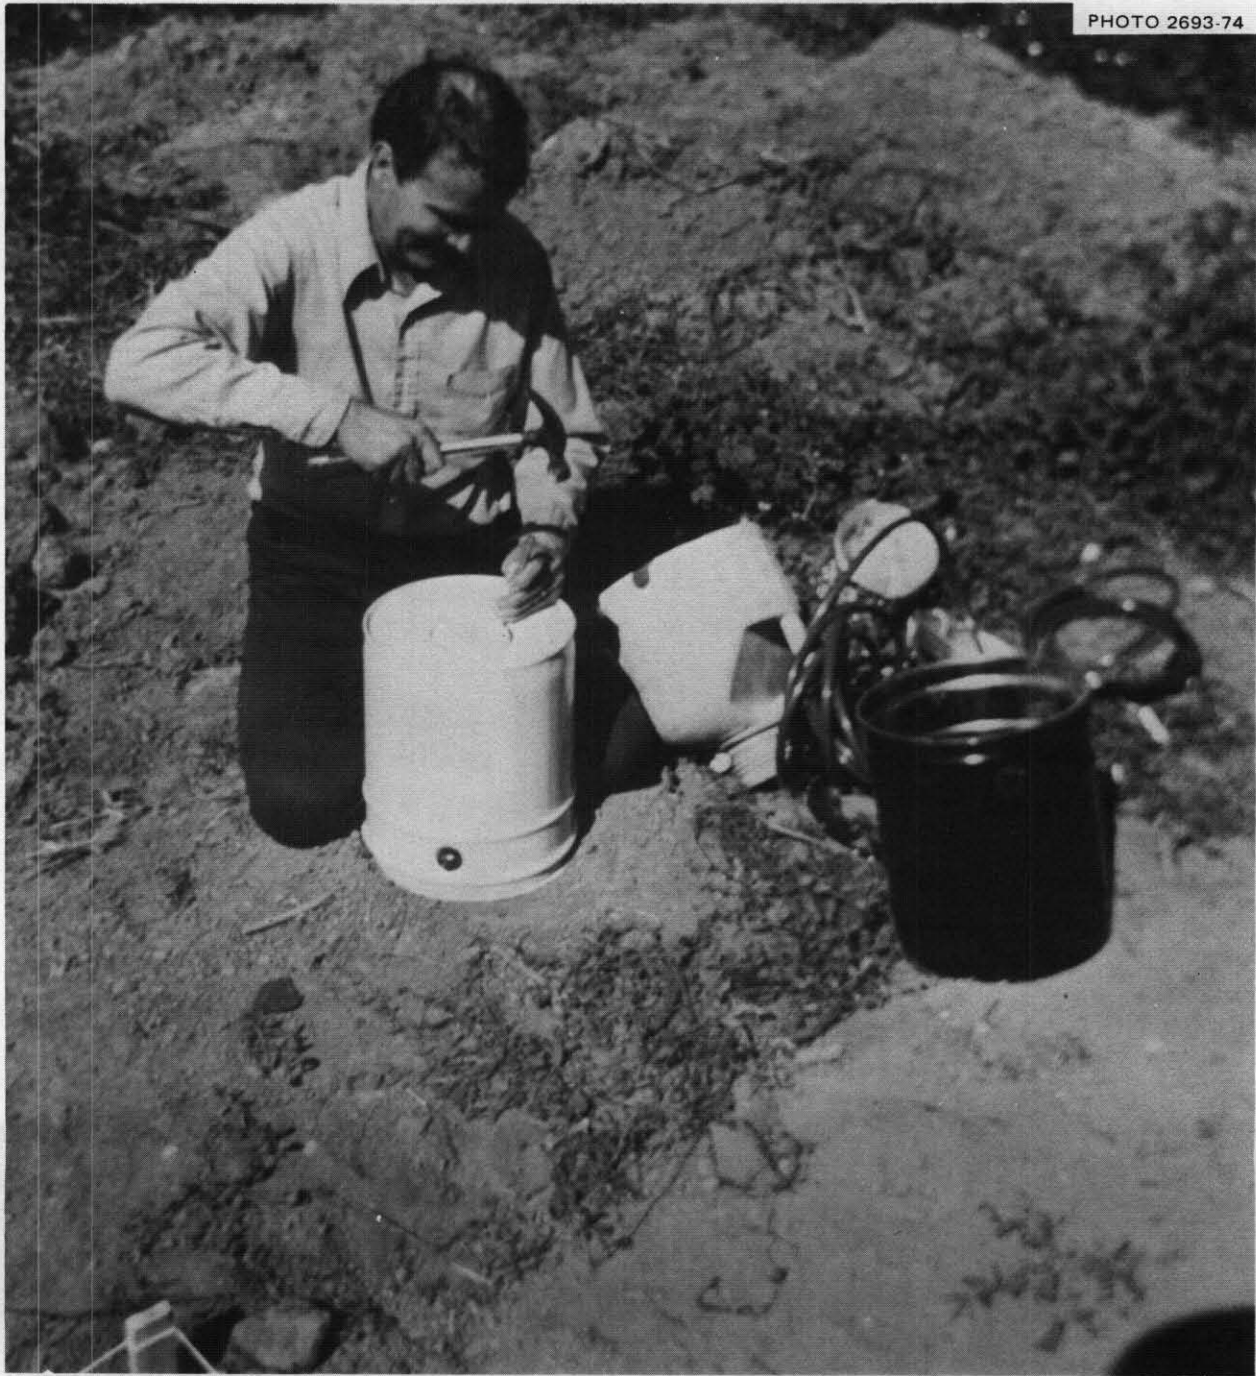
Fig. 4.25. The father starting work, with cold chisel and hammer, on his clever design of an odorless expedient toilet. In order to determine how long it would take to build and install this toilet under field conditions, he brought from his home the two 5-gallon cans, a 5-gallon plastic water jug (shown upside down), a garden hose, a complete toilet seat, an uncut piece of plywood, a tube, some cord, and freezer tape – all the materials needed to build this toilet.

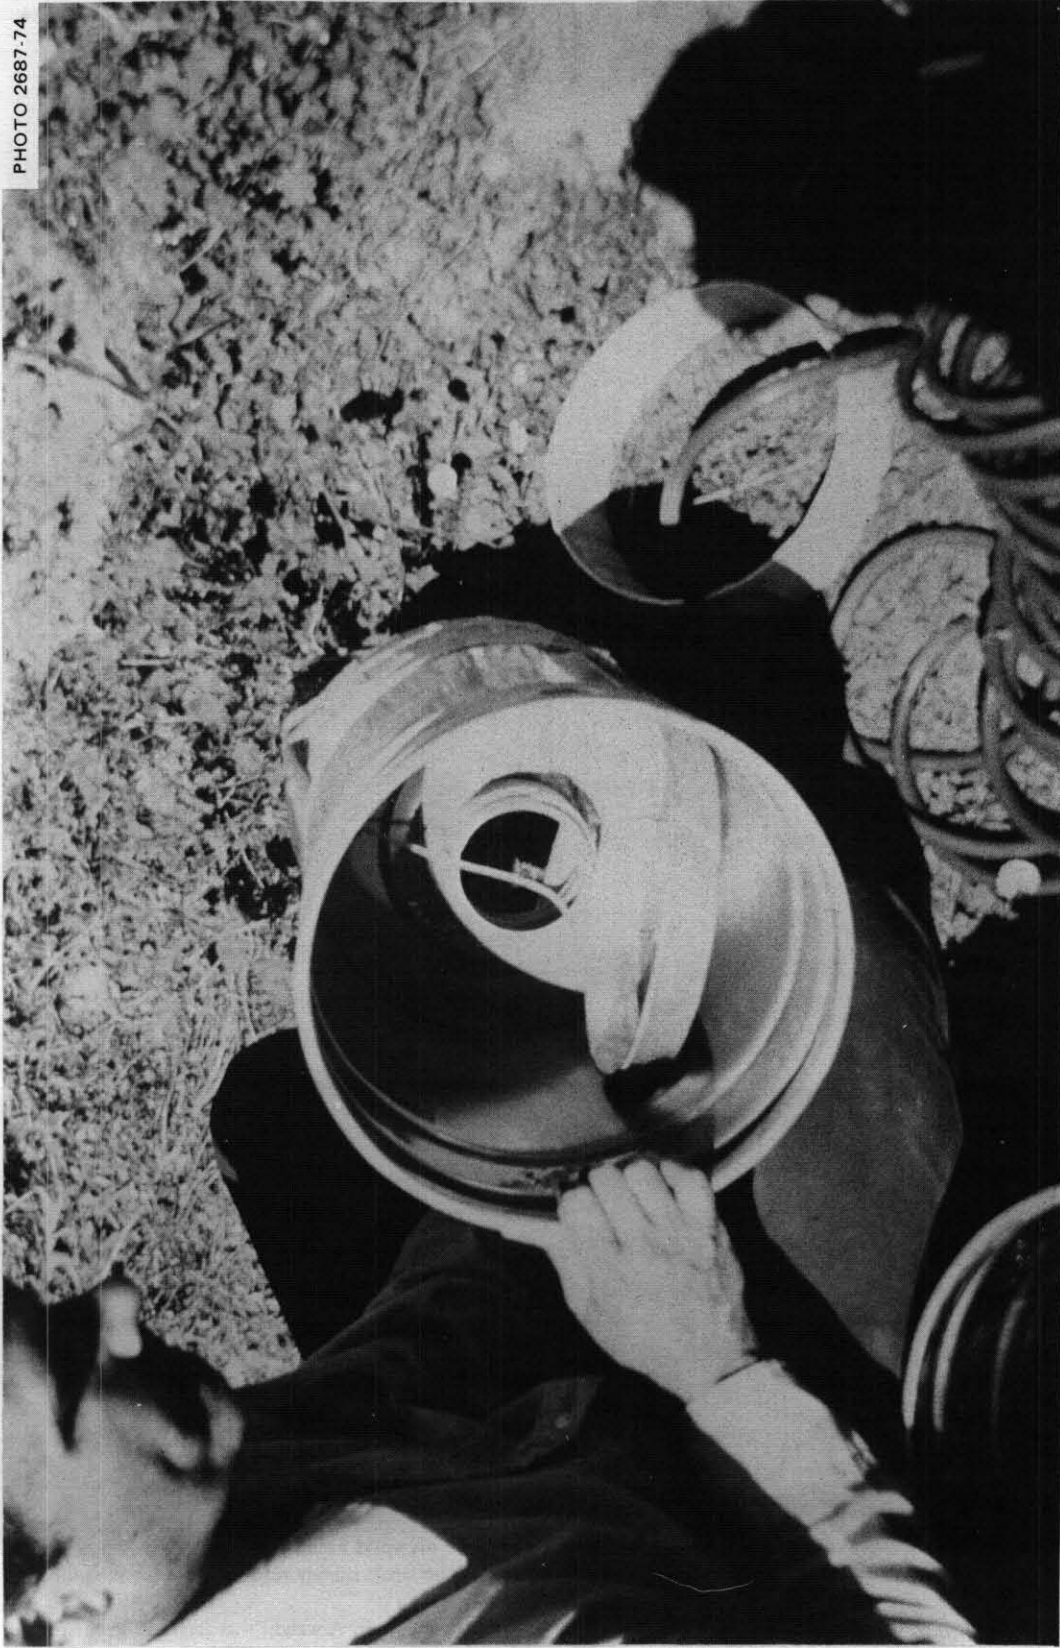
Fig. 4.27. View looking into what was to become the uppermost 5-gallon can of the 10-gallon vented space. The toilet bowl is on the ground, below this can and attached to it. The mouth of the shortened, plastic water-jug bowl is shown extending through the hole cut into the bottom of this can. Freezer tape had been used to seal the cracks between these parts.

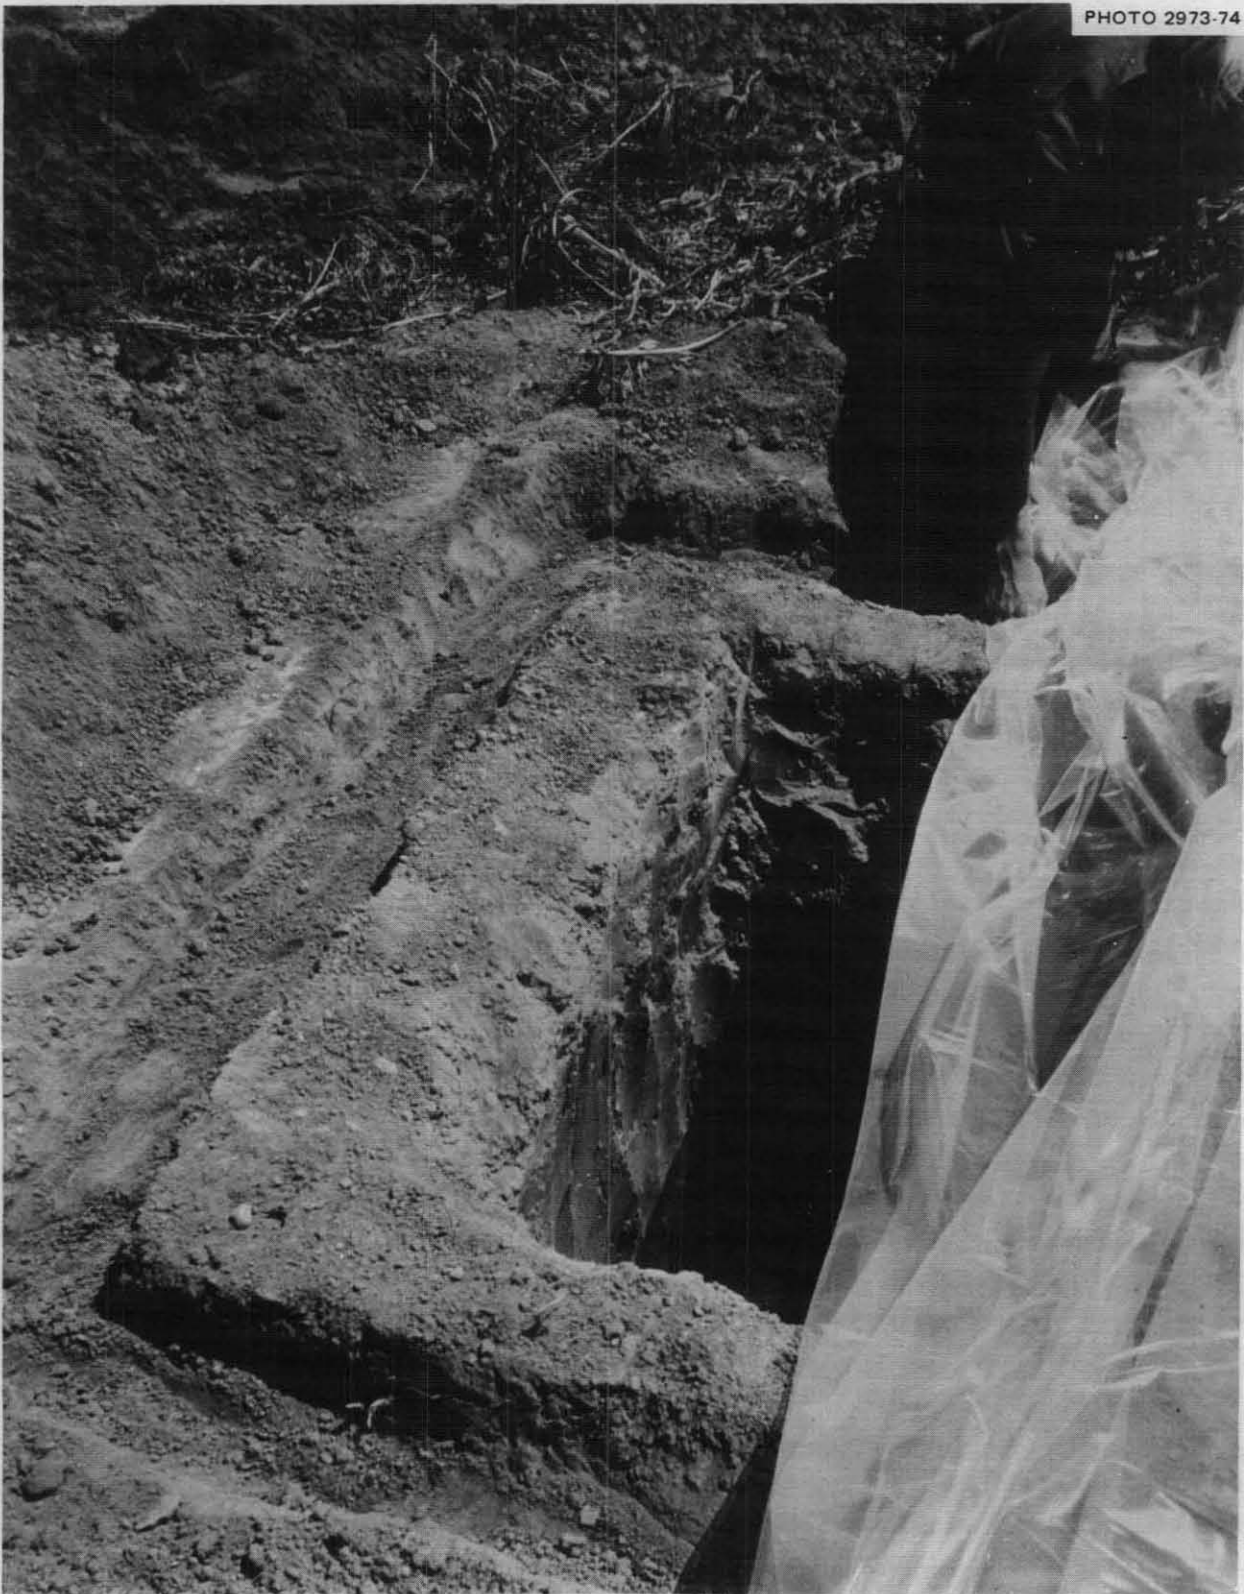
Fig. 4.34. Placing a sheet of 4-mil polyethylene in a 120-gallon water-storage pit. Unlike previous water-storage pits dug and tested by Kearny, this pit was not first lined with cloth or other material to keep sharp roots, etc., from puncturing the waterproofing plastic. All root ends were merely cut off with a knife. The edges of the plastic were folded into the small side trenches, and then held by packed earth. Six days after being filled, no leaks had developed.

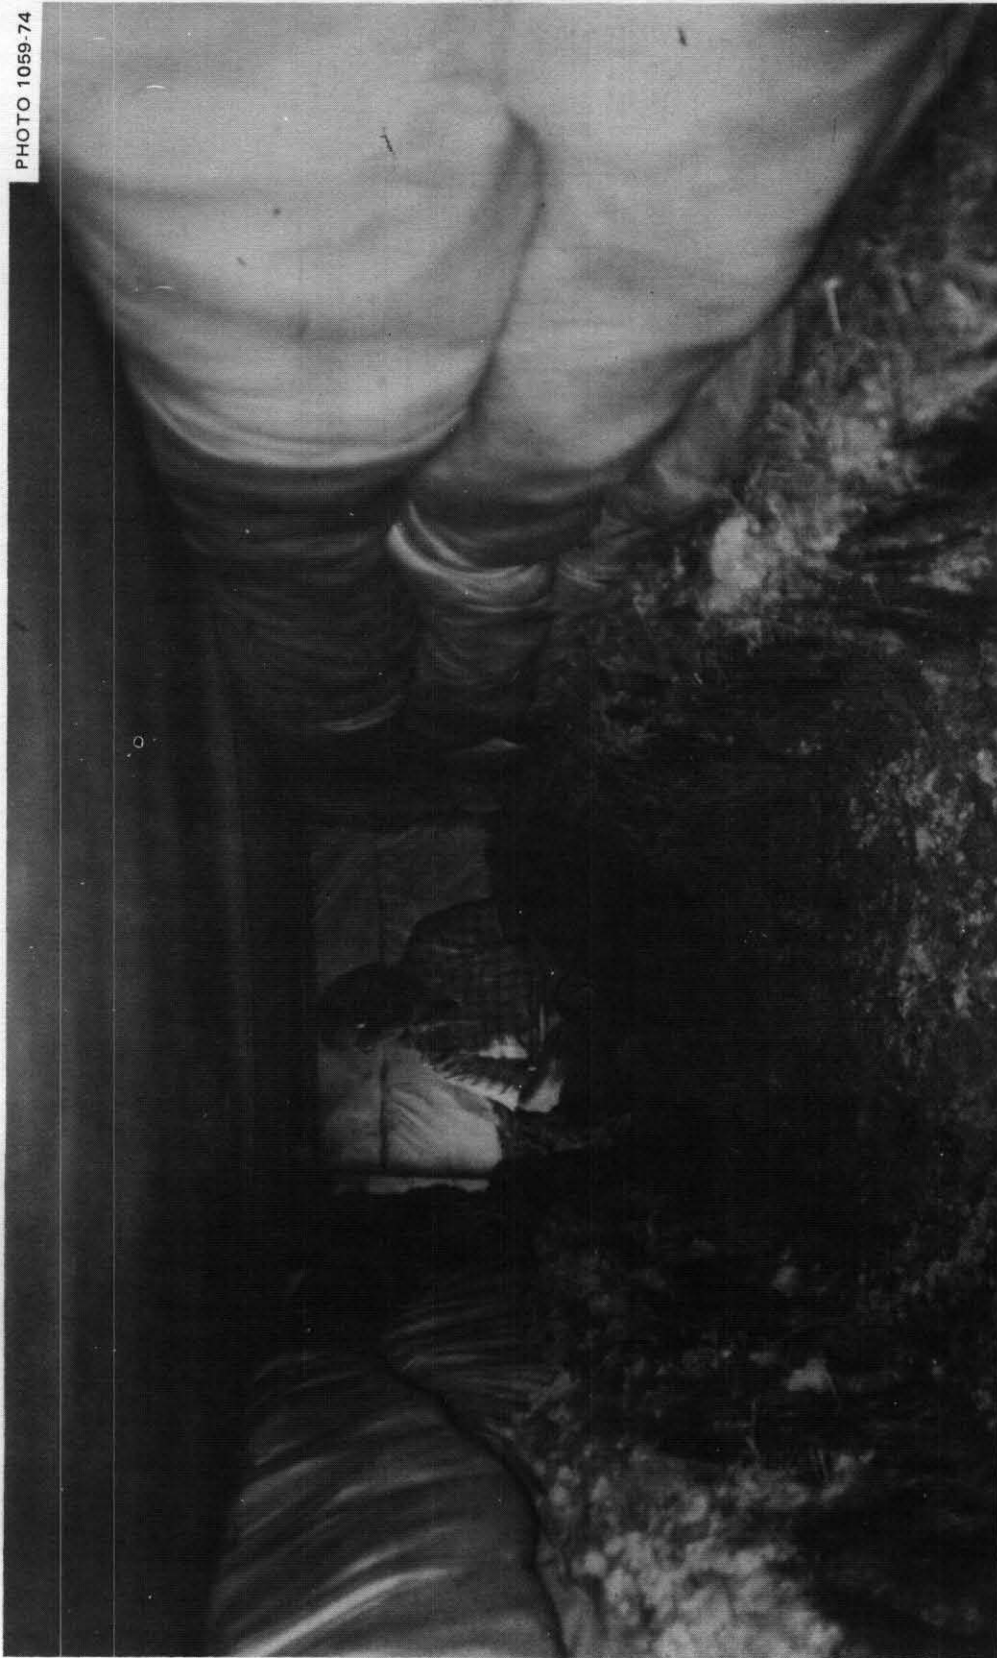
Fig. 5.12. Interior of the shelter, showing the roofing doors sloping from the right to the left, and bowed downward about 1 in. due to the 15 in. of wet earth covering them. This bowing occurred as soon as the doors were covered and did not increase during the following days.

Note how the walls near the woman have remained quite vertical, whereas the walls nearest the camera have sagged. The nearer parts of the rolls forming the walls were the first rolls made by the inexperienced builder, who was guided only by written, illustrated instructions. At first the builder failed to pull upward on the sheets before he folded them back over the mounded earth, preparatory to forming the hook.

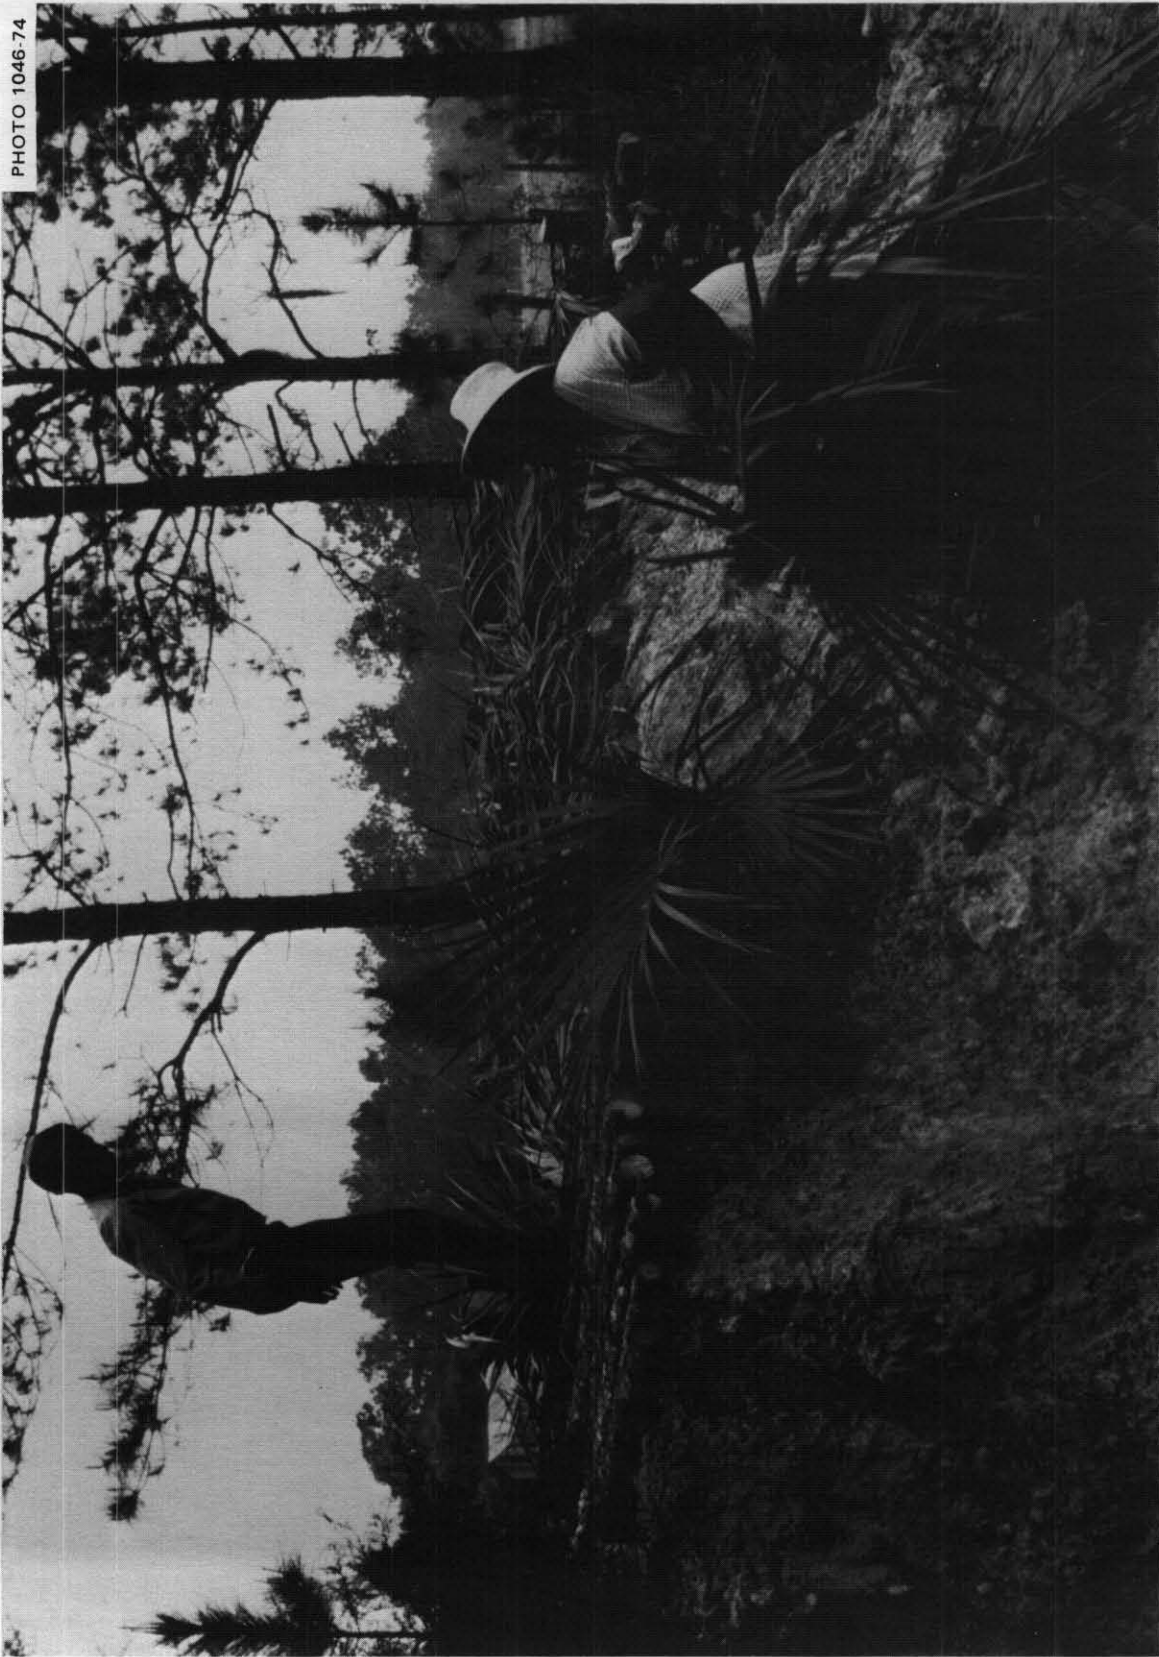
Fig. 5.21. Since this family lacked newspaper, cardboard, or other material to keep sand from sifting through the cracks between the roofing poles, they used palm leaves for this purpose. Grass or pine needles could have been used, but would have required more work, and might have contained ticks and chiggers.

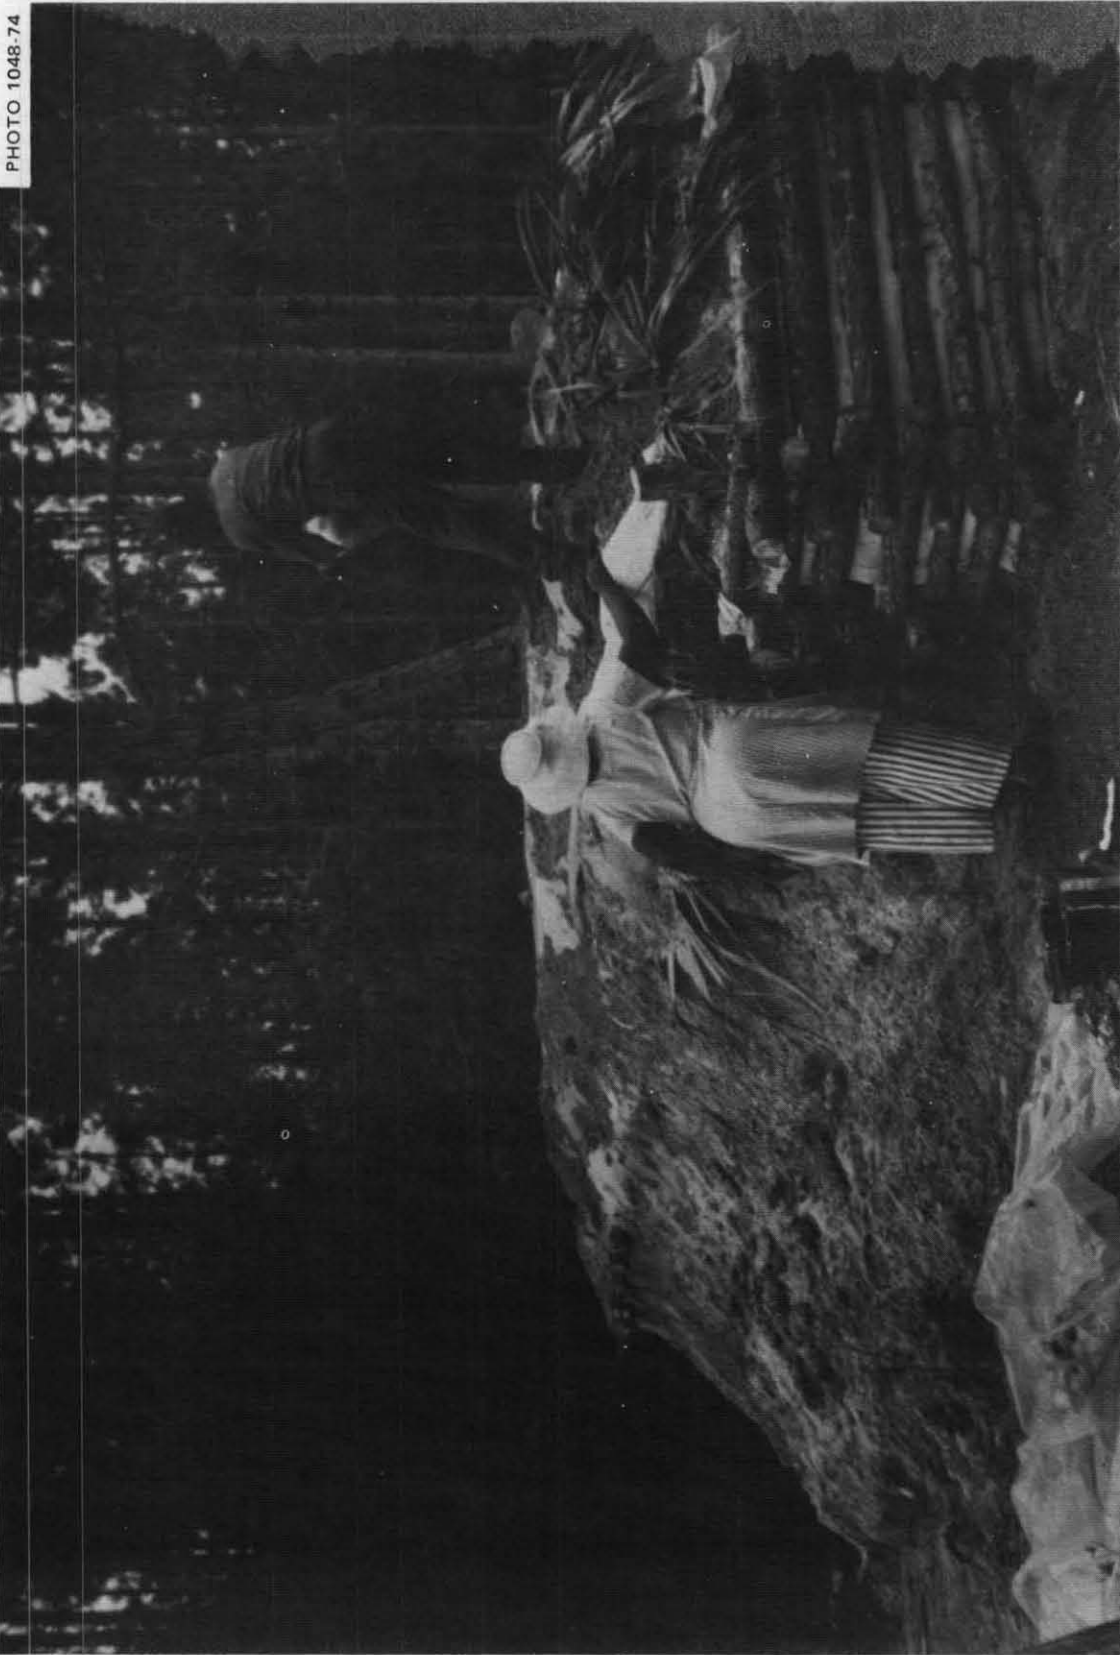
Fig. 5.23. After mounding earth over the shelter roof so that the earth was about 1 ft deep over its centerline, this family made a rainproof "buried roof" out of waterproof material. Since they had part of the north side of their home covered with a big piece of polyethylene film to keep the winter wind from blowing through cracks, they had enough waterproof material to bring with them to the shelter-building site to cover this entire shelter roof.

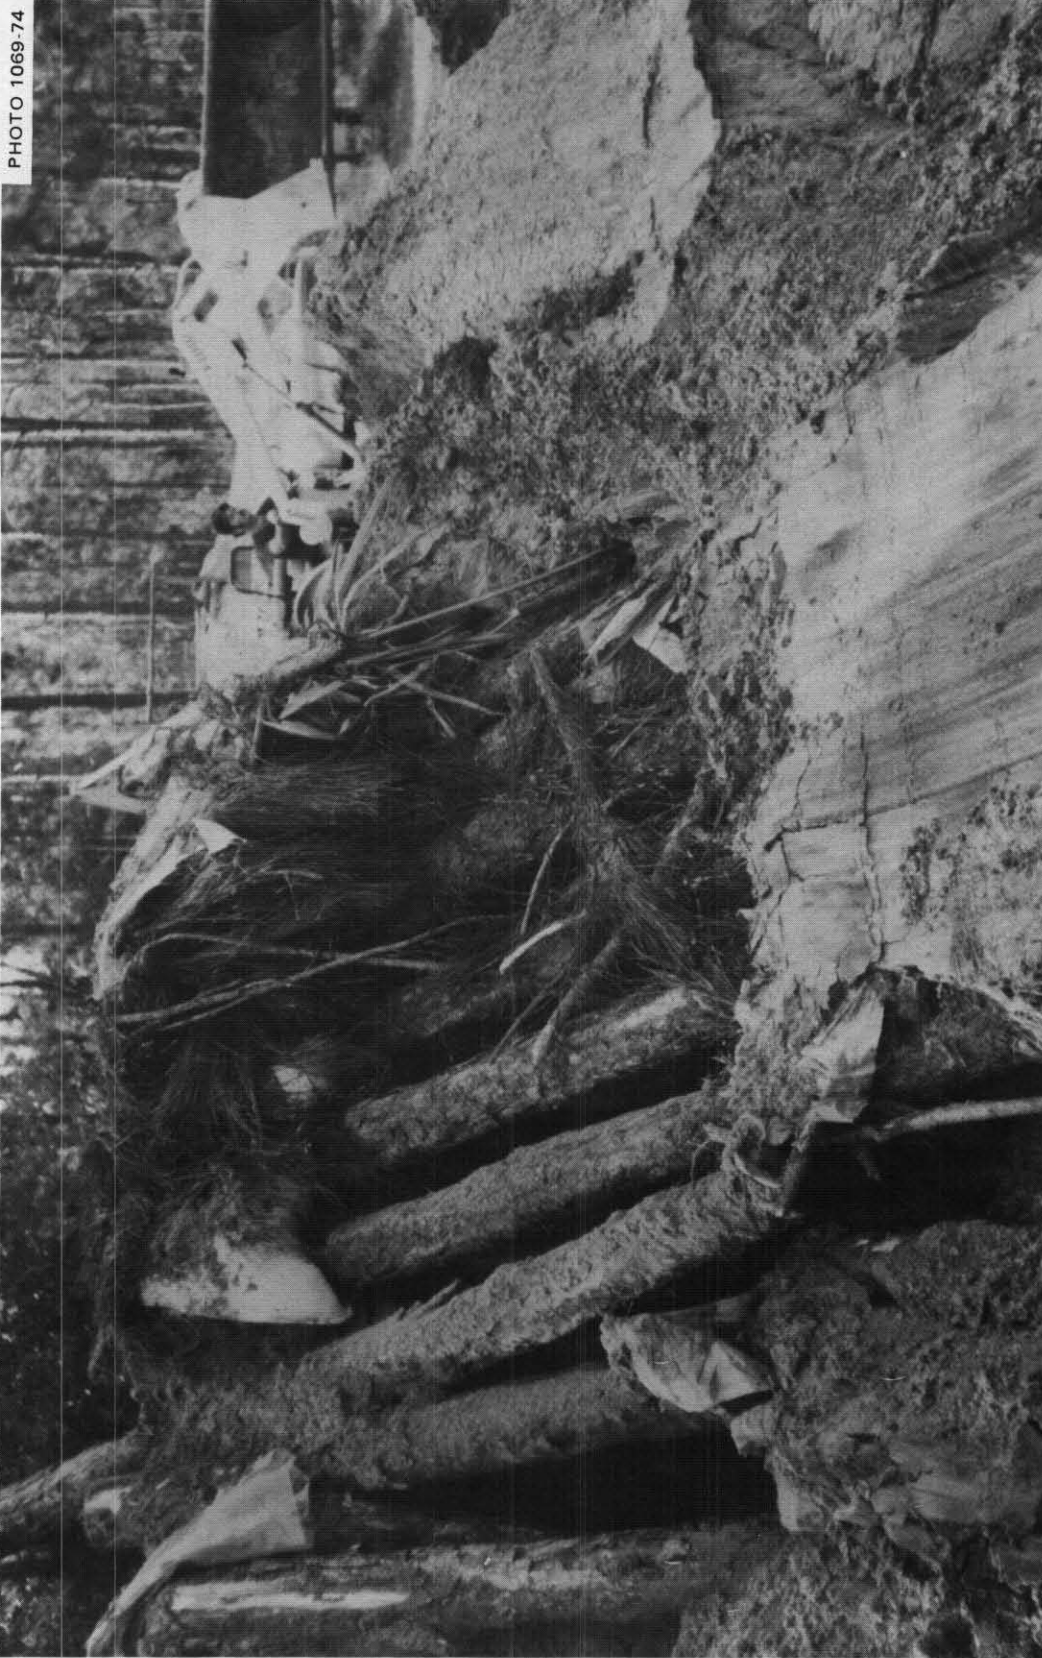
Fig. 5.40. View after a backhoe had started to demolish the Waldens' Ridge-Pole Shelter, which proved to be decidedly sturdy. Note that some of the wall poles were broken before they were moved off the ridge poles, or the ridge pole had been moved significantly.

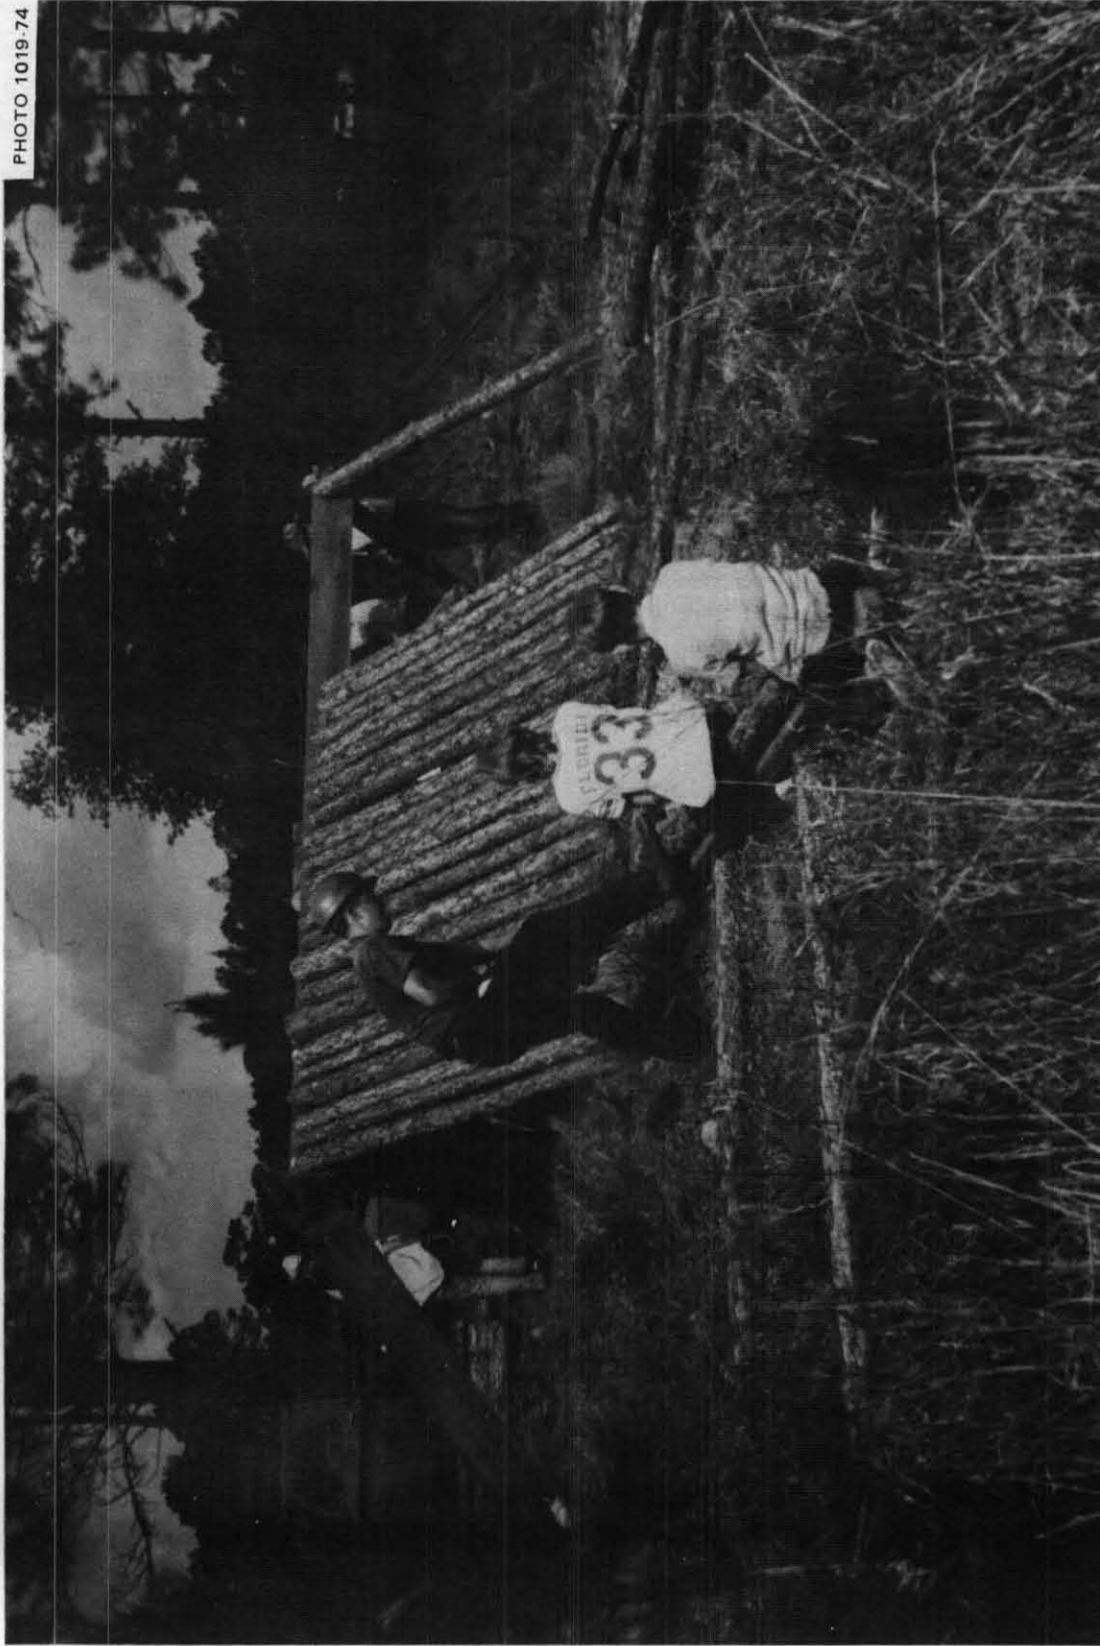
Fig. 5.45. Chain saw operator using a templet to cut an upper end of a wall pole at the specified 54° angle and 9-ft length on its short side. The templet was made from a wide 10-ft board, with one end cut at 54° . A nail was driven 9 ft from the end of this 54° angle; the squared-off base of the pole was placed against this nail.
